Report Number: BTR-02-01-2006-TBD-Sample 4
CloseFocusResearch.com

Ballistic Results

Product Number:	Sample 4 24 x 24 x 0.25 inch Plate
Sample Type:	Metal Plate
Sample Size:	24.0 x 24.0 inch
Thickness:	0.25 inch
Weight:	42.1 lbs
Weapon Type:	5.56 NATO (.223) Rifle
Cartridge / Projectile Type:	5.56 x 45 NATO (.223 Remington)
Projectile Weight:	55 gr
Target Distance:	15 ft
Number of Shots:	5 shots - shot at 45° angle

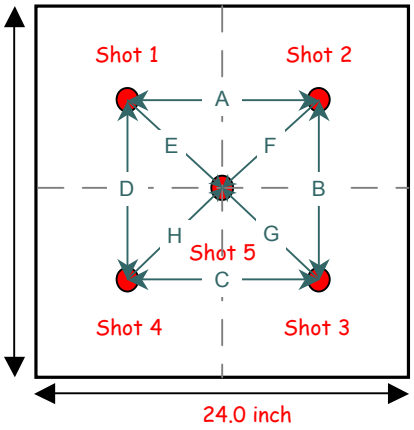
Shot Sequence:	Shot 1	Shot 2	Shot 3	Shot 4	Shot 5
Impact Velocity (ft/sec) *:	3,155	3,147	3,152	3,160	3,149
Impact Energy (ft-lbs):	1,215	1,209	1,213	1,219	1,211
Impact Momentum (lb-sec.)	0.77	0.77	0.77	0.77	0.77
Impact Angle (degrees):	45 °	45 °	45 °	45 °	45 °
Penetration Effect:	NP	NP	NP	NP	NP
Bulge Height (inches) **:	0.00	0.00	0.00	0.00	0.00

Impact Spacing (inches)		
A	4.20	
B	4.31	Average
C	4.34	4.45
D	4.96	
E	4.00	
F	3.21	Average
G	2.58	3.19
H	2.99

Witness plate material:	0.001 in. thick Aluminum foil
Witness Plate Distance:	6 inches
Spall Occurrence:	None
Test Temperature:	74 °F
Test Date:	February 1, 2006
Comments:	Passed the Test

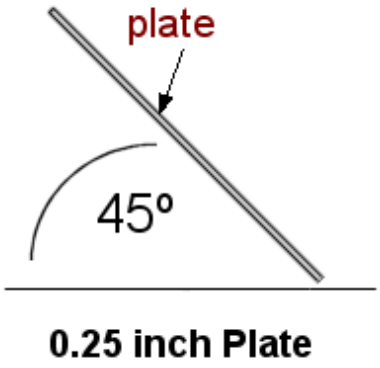
All five shots did not penetrate the metal plate. This test sample passed the modified CFR-PA-06 (.223 caliber 5.56 NATO M193) Ballistic test.

No Spall was observed.
